Grzegorz GREMZA¹
Jan ZAMOROWSKI²

DAMAGE ANALYSIS OF THE BLADE TO THE ROTOR HUB CONNECTION IN THE WIND TURBINE

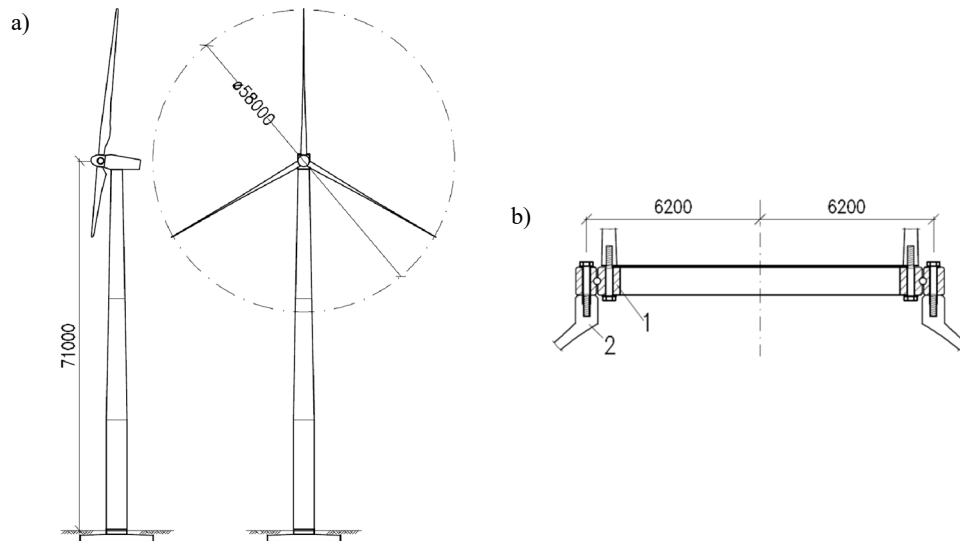
Fig. 1. Wind turbine: a) general view, b) joint between blade and hub, 1–bearing, 2–hub

In the connection of the blade to the hub four-point contact bearings, bolted on one side to the hub and on the other side of the blade, were used (Fig. 1b). The hub was made of nodular cast iron in a spherical form and fixed to the main shaft bearing. In the hub, threaded holes were made and in the blade, threading inserts were placed. To connect the bearing to the hub, 52 bolts M24 class 10.9 with the mark W of the manufacturer and with the additional marking U (10.9U) i.e. with undersized thread were used (Fig. 2). Such a thread is sometimes executed to maintain the required minimum clearance for the threaded connection after applying a thick layer of zinc coating in the hot dip galvanizing process.

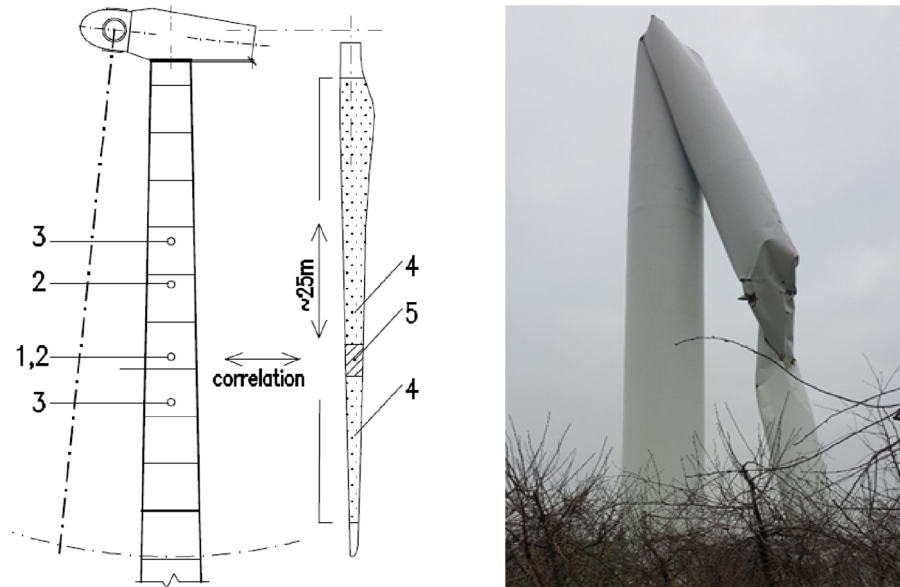
The disaster was preceded by a period of a few days strong winds, during which the wind turbine was at least twice immobilized: for the first time automatically due to exceeding the permissible wind speed and for the second time due to lack of power supply. A few minutes after it was restarted, disaster has occurred. One of the blades crashed into the tower causing its brake-down (Fig. 3), what was observed by the windmill owner. This blade was detached from the rotor and discarded (thrown) far away from the windmill. During the in-situ inspection, it was found, that this blade's shells have been stripped off (Fig. 4a) and its supporting beam (spar) has been partly broken at the point of impact on the tower. A view on a bearing devoid of broken bolts has been shown in Fig 4b.

Fig. 3. Wind turbine damage: 1–point of the blade impact, 2–ends of twisted section, 3–ends of braking, 4–area of a blade without shells, 5–broken section of a blade

The shaft of the tower in the level of the blade's impact has been twisted, which may indicate a hit as a factor initiating its collapse. On the basis of calculations, the tower collapse due to its insufficient load capacity was excluded. The tower was calculated assuming that the level of its quality declared in the documentation was preserved. It was decided to carry out a wide-spread analysis of the whole structure as well as possible problems in the connection.

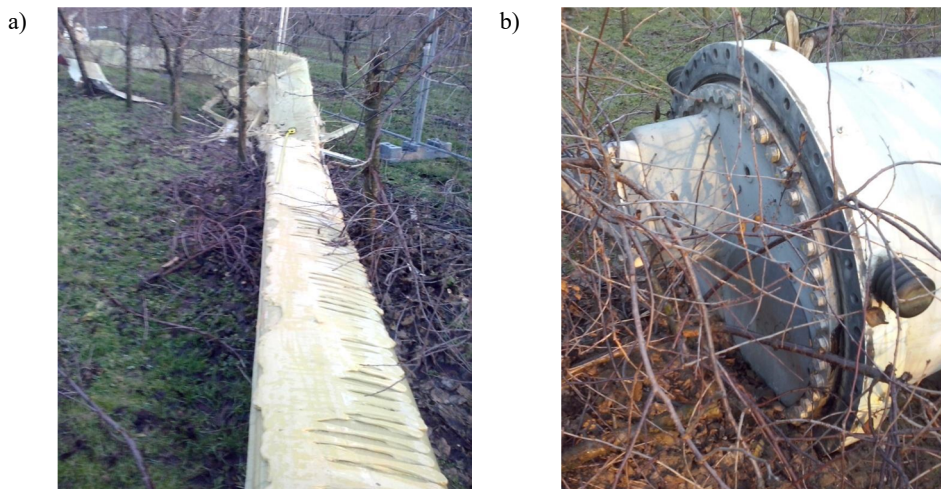
Fig. 4. Detached blade: a) supporting beam without shells, b) bearing without bolts

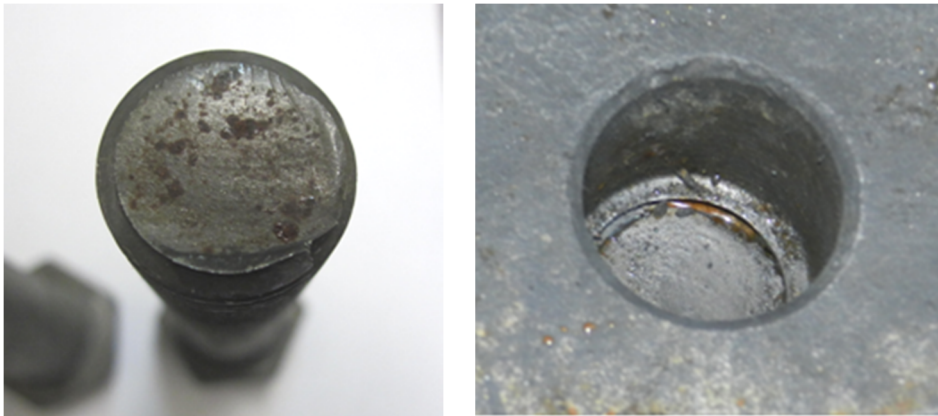
The immediate cause of the failure of the blade-to-rotor connection was a fracture of bolts, what is rare in wind turbine failures. During the inspection it was found, that some of the bolts at about 1/3 of the circumference of the joint were destroyed with very small elongation or brittle (Fig. 5).

Fig. 5. The brittle fracture surface of bolt and a hole with end of bolt

The remaining bolts on about 2/3 of the circumference of the joint were destroyed plastically, some of them with very visible elongation and necking, which were estimated at up to 20%. The fracture surfaces of a part of bolts indicated a brittle fracture.

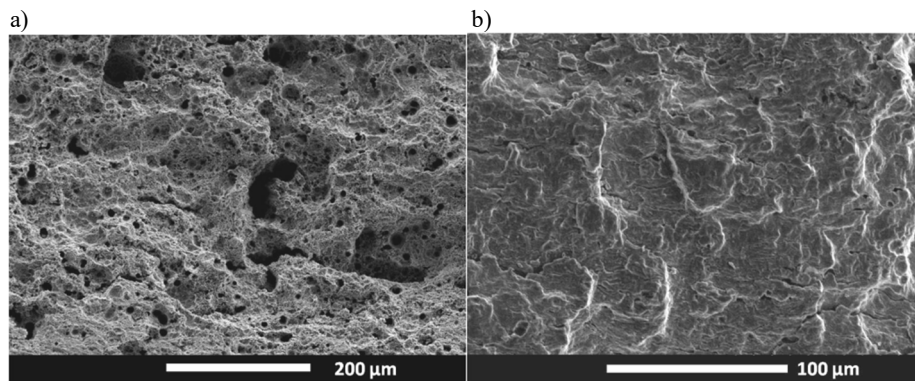
The fracture surfaces of three selected bolts were examined. Tests confirmed macroscopic observations regarding the manner of their destruction. The fracture in bolt '1' was characterized with a ductile morphology with characteristic cavities (dimples) typical of this type of fracture (Fig 6a).

Fig. 6. Fracture surfaces of bolts: a) ductile of bolt 1, b) brittle of bolt 3

Such a fracture testifies destruction of the material after exceeding the yield point. The fracture of bolt 3 was mainly brittle (Fig. 6b) and the fracture of bolt 2 was mixed (both brittle and ductile).

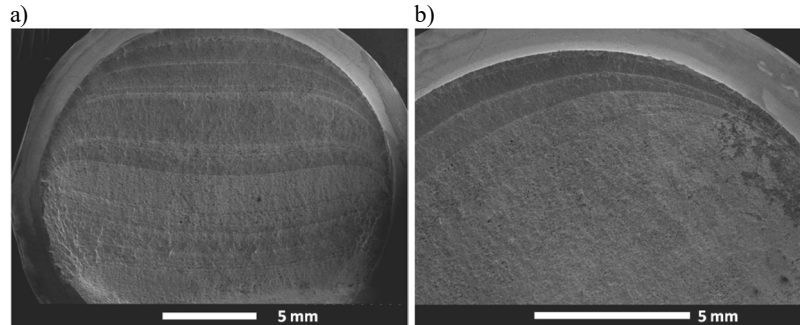
Almost over the whole surface of the fracture of bolt 3, characteristic lines resembling fatigue beach marks are visible (Fig 7a). The areas between these lines are brittle. The appearance of the fracture suggests that the material was destroyed gradually, e.g. during alternating bending of the bolt. On the fragment of the fracture of the bolt 2, near its surface, characteristic lines indicating the fatigue cracking are also visible (Fig. 7b). Such a character of the fracture, at the surface, can occur not only as a result of alternating bending of the bolt but also in the case of hydrogen-induced cracking.

Fig. 7. Fracture surfaces of bolts: a) bolt 3, b) bolt 2

Theoretically, there should be no significant stress amplitudes in a preloaded bolt, what is reflected in the recommendation given in standard [2] allowing to adopt a reduced range of stress fluctuating for such a bolt. The brittle fracture of the bolt material characterized with symmetrical fatigue beach marks (beach lines) relative to the axis passing through the centre of the cross-section (see Fig. 7a) may indicate an alternate bending of the bolt after a separation was created in the connection of the blade with the rotor. Therefore, the hypothesis may be put forward, that the bolts in the tensioned zone had broken up first. Then, in partly damaged joint an alternate bending of bolts in compression zone and as a result their fatigue failure occurred.
