Dorota PAPCIAK¹
Justyna ZAMORSKA²
Monika ZDEB³

TREATMENT OF TECHNOLOGICAL WATER FOR THE AEROSPACE INDUSTRY – OPERATING PROBLEMS

Keywords: polymerized forms of silicates, water treatment, FPI - Fluorescent Penetrant Inspection

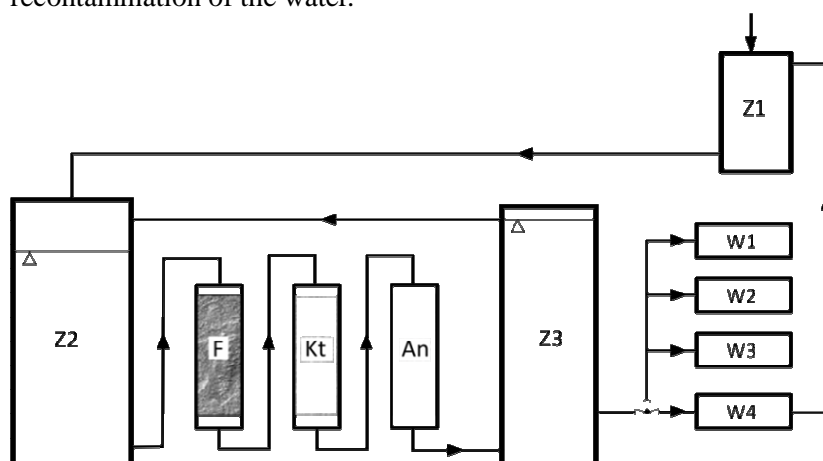
Fig. 1. Schematic diagram of FPI line

Fluorescence and cleaning Line in the facility consists of four bathtubs. Rinsing the elements is produced by using the preparations which are driven by means of penetrants, developers, emulsifiers and removers (ZYGLO, TURCO and ARDROX). The last of the bathtubs, which is rinsing with clean water in a closed circuit is turned on, connected with the renewal of water. In circulation it includes: a water tank which adds water in the installation of the capacity of 1.8 m³ Z1, two tanks for technological water Z2, Z3, two with a capacity of 10.5 m³ each, gravel filter F, cation exchanger Kt, anion exchanger An, bathtubs W1-W4. FPI line diagram is shown at the Fig. 1.

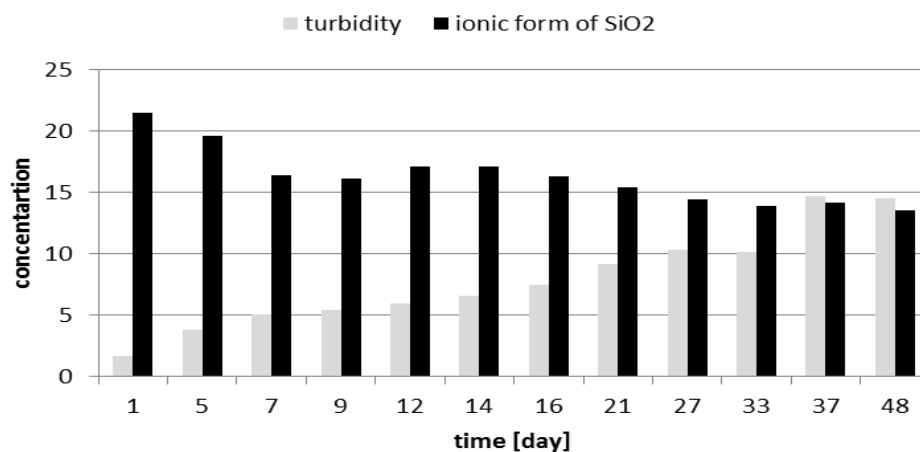
Fig. 2. Change the parameters of rinse water

Silicates present in water (Fig.2) attest to the fact that treatment is designed to remove all ions with the exception of silica. The literature indicates that in water solution alkali silicates, for example potassium silicate or sodium, are hydrolysed and produce silicic acid. The acid tends to drainage and condensation

with the creation of polysilicon acids. The process of condensation is accompanied by the formation of more and larger molecules, which show a lower solubility in water, giving the colloidal solutions. Better condensates, evolve in the form of gelatinous sediment. The speed of the condensation process largely depends on the pH of the solution, it is the largest in cases where the pH is 6-7 and clearly decreases when the acidity increases or decreases. In aqueous solution strongly alkaline pH approx. 13 and in strongly acidic aqueous solution (pH 2-3), the rate of condensation is very small and diluted a silicic acid is stable. In the natural waters the silicates may exist in the form of ortho-, meta-, and in the form of polyacids. Dissolved in water, there are gems in dissociated form but lowering the pH below the 8.3 undoes dissociation which promotes the formation of polyacids and extract the silica in solid form [1]. Polymerized silicates occur in colloidal form, so it is observed an increase in turbidity and reduce the silicate dissociated content (Fig.2). Other parameters fluctuate slight extent and during the process there is no clear trend of their changes (Tab. 4.).

1. The cause of the deterioration of the quality of the rinsing water and the formation of deposits on the elements is its technology of cleaning.
2. The results of the analyses indicate that the cause of the growth of technological water turbidity on the FPI is formation of polysilicon acid.
3. Polymerized forms of silicates exist in colloidal form, therefore, the observed phenomenon is the emergence of so-called "white water" and the formation of deposits.

It seems necessary to supplement the system of additional filter of strongly basic anion exchange resin. Mechanical cleaning combined with disinfection of demineralization station causes temporary improvement, however, the issue of deterioration of water quality persists.

4. Improvement of technological water quality can be achieved by:
- carrying out a thorough cleaning of rinsing system and removal of accumulated sediments,
 - maintaining the technological regime on individual stages of the process of rinsing,
 - the insertion additional, strongly alkaline anion exchanger working in hydroxyl circle, in order to continuously removing silicates from the water.
