Irena ICKIEWICZ<sup>1</sup>  
Piotr KODA<sup>2</sup>

## THE INFLUENCE OF THE ENVIRONMENT ON OBJECTS OF HISTORICAL VALUE

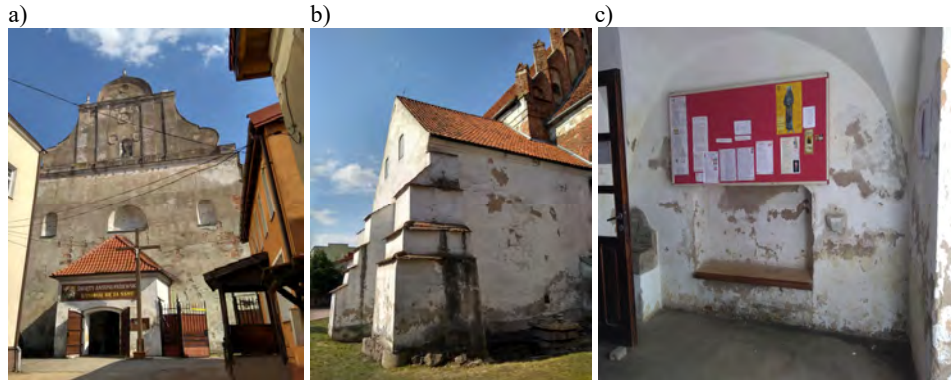
A historical church in Barczewo under the invocation of St. Andrew the Apostle was erected in XIV century as a single-nave, gothic church made of ceramic bricks. The scale of damage caused by damp is very significant (fig. 1).

Fig. 1. St. Andrew's church in Barczewo - a) main entrance b) damaged side elevation  
c) multiple traces of damp visible on the walls from the inside

- In the analyzed objects, especially on St Andrew the Apostle's church in Barczewo, with walls being wet to such an extreme degree, (22% on the floor level and between 17% and 18% at 1.80 m) the analyzed walls should be without a doubt subject to dynamic drying, using the most efficient drying method.

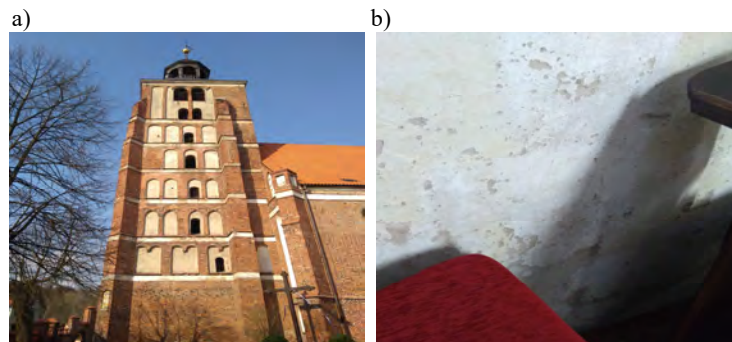
The church was erected in XIV century; gothic. The church's vaulting were designed as arch and stellar vault. The church is made of full ceramic brick, plastered interior (fig. 2).

Fig. 2. St. Anna's Church in Barczewo- a) general view of the elevation, b) visible signs of damage cause by capillary and condensation damp

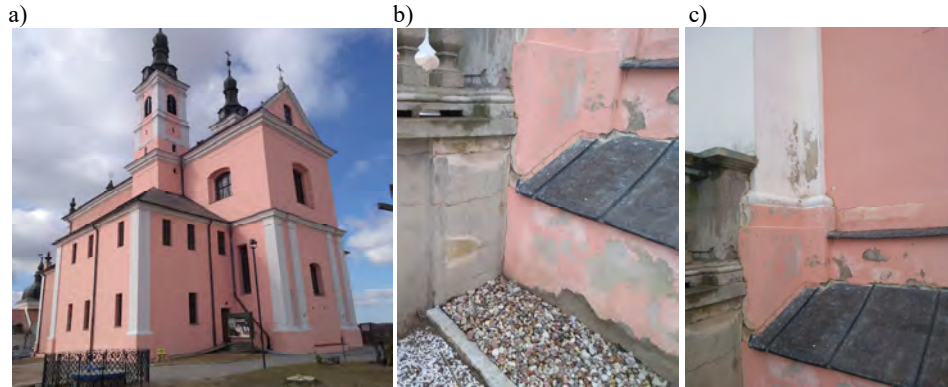
A historically significant church under the invocation of St. Mary's Immaculate Conception in Wigry, erected in XVII century, a baroque, single-nave design made out of full ceramic bricks, plastered on the inside (fig. 3).

Fig. 3. A church under the invocation of St. Mary's Immaculate Conception - Wigry, a) general view of the building complex b) and c) visible outer layer damage caused by damp

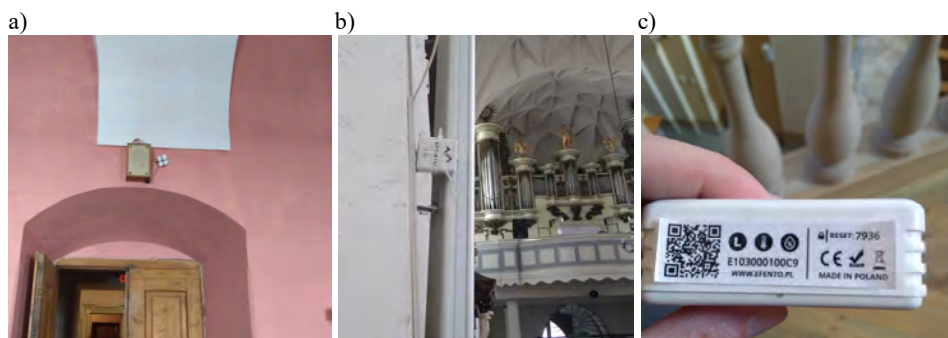
The recorders that were used are powered by batteries (2 years of continuous operation). The recorders were mounted on the objects between January and February 2018. With the goal of correctly interpret the conditions present in the churches, the recorders were mounted on 2–3 places in equal distances from each other. The recorders mounted in 3 churches are shown in fig. 4.

Fig. 4. Mounted sensors for measuring the temperature and humidity of the interior air  
a) in a church in Wigry over the entrance b) in the St. Andrew the Apostle's church in Barczewo  
c) in St. Anna's church in Barczewo d) general view of the mounted sensors

The recorders were mounted on 7.01.2018 in the church in Wigry and on 9.03.2018 in both churches located in Barczewo. In the St. Andrew the Apostle's church, 3 sensors were mounted, in the side nave, in the main nave and at the matroneum.

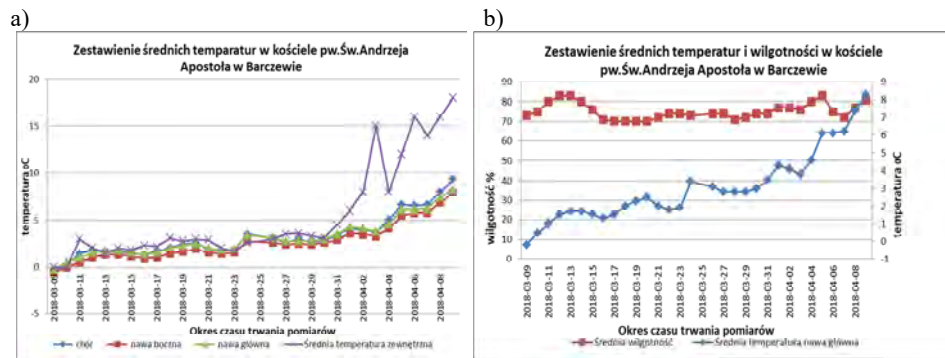
Fig. 5. Temperature and dampness levels as a function of time; 5a) levels of interior air temperature in 3 measurement points + the temperature of exterior air, 5b) temperatures and humidity of interior air – Barczewo (1)

Diagrams of air temperature and humidity values included in fig. 5–6 pertain to 3 churches (Wigry and 2 Barczewo churches). In order to determine whether the location of gauge placement in the building had influence on the levels of temperature and humidity (fig. 5a), the gauges in St. Andrew the Apostle's church were located in the side-nave and at the matroneum. It turned out that the differences in temperature values are insignificant and amount to between 0.8°C and 1.5°C. The highest temperatures were recorded at the matroneum but a significant influence of the exterior temperature on the interior temperatures.

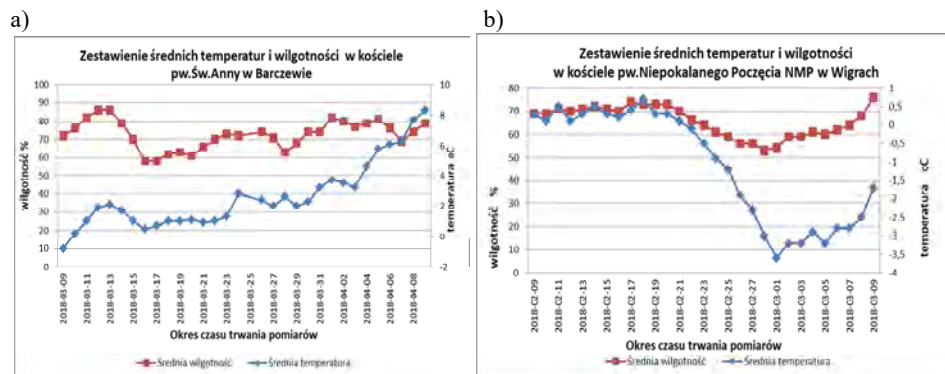
Fig. 6. Temperature and dampness levels as a function of time) a) temperatures and humidity of interior air - Barczewo (2) b) temperatures and humidity of interior air – Wigry

Measurements from both Barczewo churches were included for the period of 9.03.2018 and 8.04.2018. Diagrams 5b and 6c show the dependence of the relative air humidity on interior air temperature in Barczewo churches. Due to low temperature fluctuations (max. 3°C) in the period of 15.03 and 4.04. the air humidity values were also not significantly different and remained at the level of ~70% in St. Andrew the Apostle's church and in St. Anna's church between 60% and 70%. Noticeable differences in humidity occurred in the first week of measurements and in the last couple of days, where the exterior air temperature has increased significantly. In the Wigry church, measurement results were included for the period between 9.02. and 9.03.2018, which causes the distribution of temperature and humidity values to be significantly different (fig. 6d). A conspicuous dependence of interior air humidity on temperature was observed. It was also noticed that the decrease in interior air temperature happened when interior air temperature was negative. Despite the interior temperatures in St. Anna's church being relatively stable, a noticeable spike of ~ 30% in relative air humidity values within a few days was noticed. This phenomenon poses a challenge to be interpreted (fig. 5a). Based on wall dampness results, it was concluded that in all the analyzed cases, the walls are wet within their entire measured height (from 0.2 m to 1.80 m). The dampness of walls exceeded the allowed value of 4% and was recorded at between 17% and 22%.
