Tomasz SIWOWSKI¹
Maciej KULPA²

FATIGUE TESTS OF WELDED JOINTS IN STEEL ORTHOTROPIC BRIDGE DECK

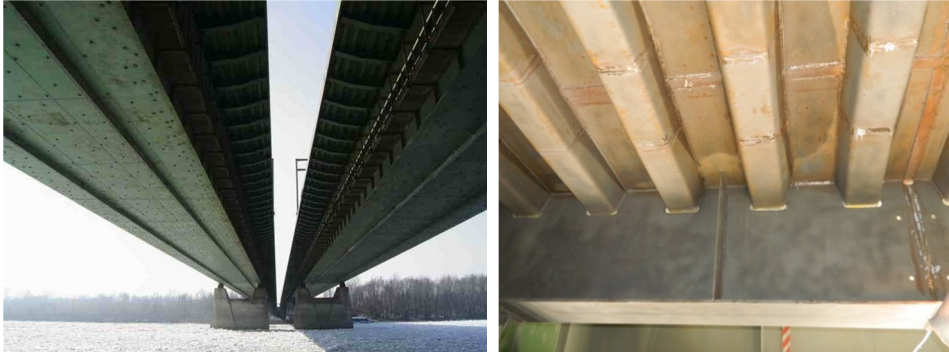
Fig. 1. The Grot-Rowecki Bridge: general view of box girders (left), the orthotropic deck (right)

The orthotropic bridge deck consists of steel plates stiffened with longitudinal trapezoidal closed stiffeners and T-shaped cross-beams (Fig. 1b). The thickness of the deck plate varies from 12 mm in the middle to 28 mm in the support regions of the spans. The trapezoidal stiffeners are made of cold-formed 8-mm plates and continuously go through the webs of cross-beams. The axial distance of the stiffeners is 600 mm and their depth is 178 mm. The cross-beams are made up of 12-mm web with the depth of 850 mm and bottom flange with 20×400 mm cross-section. They are placed every 2 500 mm along the bridge. The whole steel superstructure was completely welded and is made of 18G2A steel grade (S-355 according to current codes).

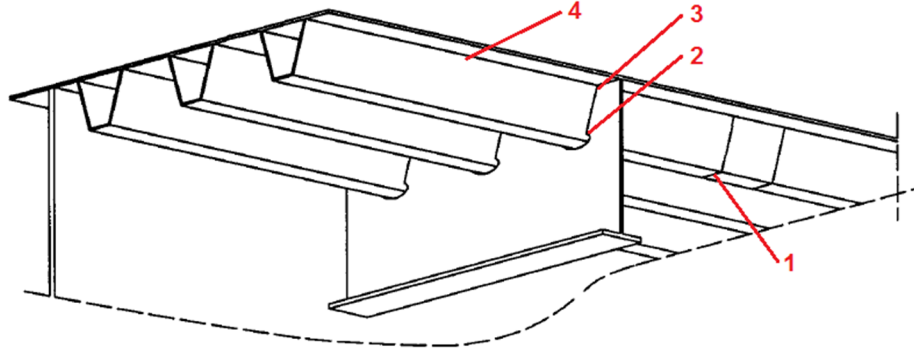
Fig. 2. Critical welds of the deck chosen for preliminary evaluation

In order to identify the welded connections which are critical in terms of fatigue, apart from the visual inspection of the deck structure, the calculations were conducted and the critical regions were chosen for preliminary evaluation of the deck (Fig. 2). For the calculation of stress ranges in the chosen details, the part of the orthotropic deck with the length of 13.0 m was modelled, comprising 5 spans of longitudinal stiffeners supported on 6 cross-beams. A beam and shell elements in FEM *Sofistik*-code environment were used for deck modelling. Using 3-D structural model of the orthotropic deck, the inner forces and corresponding maximum and minimum stresses in all relevant details were calculated and followed by establishing stress ranges applied for the fatigue evaluation [9].

Table 1 shows the fatigue safety calculations (μ_{fat}) for selected critical details (Fig. 2). This way two critical details of the deck were determined with the fatigue safety level $\mu_{fat} < 1.0$: the fillet weld connecting the deck to trapezoidal stiffener (detail no. 1 in Fig. 2) and the splice joint in stiffener, full penetration butt weld with steel backing plate (detail no. 4 in Fig. 2).

Detail no. 1 was the fillet weld connecting the deck slab to the trapezoidal stiffener (Fig. 2). In this case the fatigue assessment is based on the direct stress range from bending of the deck plate. Therefore the main point of interest was the fatigue strength of the deck plate under the bending stresses imposed by wheel loading. Testing was carried out on full-scale one-stiffener specimens, consisted of a 300-mm-long single stiffener with accompanying part of the deck plate 700 mm wide (Fig. 3a). Twelve test specimens were cut out of three different parts of the deck, located on three relevant spans of the bridge and along the slow lanes of the deck.

Detail no. 4 was the splice joint in a stiffener, full penetration butt weld with steel backing plate (Fig. 2). In this case the fatigue assessment is based on the direct stress range $\Delta\sigma$ in the stiffener. Testing was carried out on small strip specimens cut out of the full-scale splice joint. This was a tensile fatigue test on a butt-jointed plate, $600 \times 90 \times 12$ mm thick (Fig. 3b). These test specimens were cut out of four different parts of the deck, located on four relevant spans of the bridge and along the slow lanes of the deck.

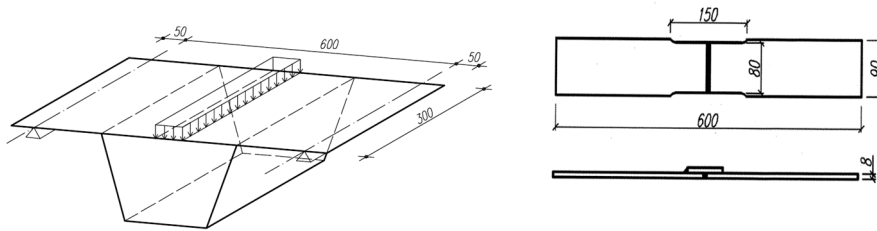
Fig. 3. Fatigue test specimens: weld no. 1 (left), weld no. 4 (right)

For the reliable fatigue assessment of existing welded structures the detail categories $\Delta\sigma_C$ given in [7] should be determined by means of the specific fatigue tests. In our case the fatigue tests were carried out for both critical details (no. 1 and no. 4). Test specimens were cut out of the existing orthotropic deck (Fig. 3).

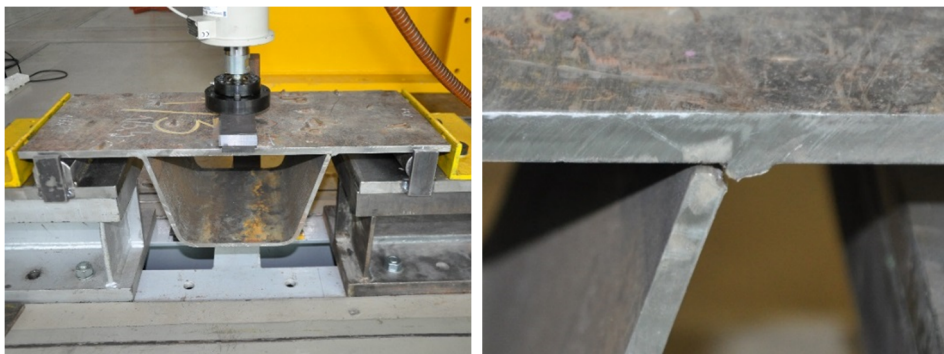
Fig. 4. Detail no.1 under testing: loading scheme (left), typical fatigue failure (right)

The test involved one mode of fatigue loading at the frequency of 5 Hz, i.e. on the deck at the stiffener centre-line, with the specimen supported symmetrically (Fig. 4a). Using the test specimen and the loading shown in Figure 4a the approximation of the actual loading conditions was achieved. The load value F and relevant stresses in the vicinity of fillet weld was evaluated

on the basis of the FEM calculations using the numerical model of specimen validated against the strain measurement done on the actual bridge deck before fatigue specimens were cut out. The stress ratio at the weld toe in the deck plate was assumed as $R = 0.1$ with constant amplitude loading.

The series of 6 specimens was tested at the stress ranges $\Delta\sigma$ between 160 and 220 MPa. All specimens failed in the weld as a result of fatigue crack propagation from the weld root through the stiffener (Fig. 4b). It was induced by the transverse bending of the deck plate. The results of the tests of a fillet weld connecting the deck plate to the trapezoidal stiffener are shown in Table 2.

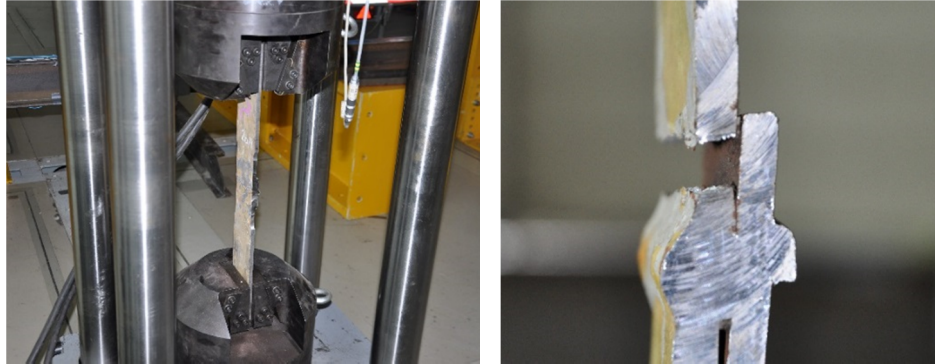
Fig. 5. Detail no. 1 under testing: loading scheme (left), typical fatigue failure (right)

The small strip specimens were loaded in tension at a frequency of 5 Hz. The stress ratio at the weld in the stiffener bottom plate was assumed as $R = 0.1$ with constant amplitude loading. The series of 7 specimens was tested at the stress ranges $\Delta\sigma$ between 120 and 200 MPa. Most specimens failed in the weld as a result of fatigue crack propagation from the weld root through the plate (Fig. 5b). One run-out was observed at $\Delta\sigma = 120$ MPa. The results of the tests on a penetration butt weld with steel backing plate in stiffener are shown in Table 3.

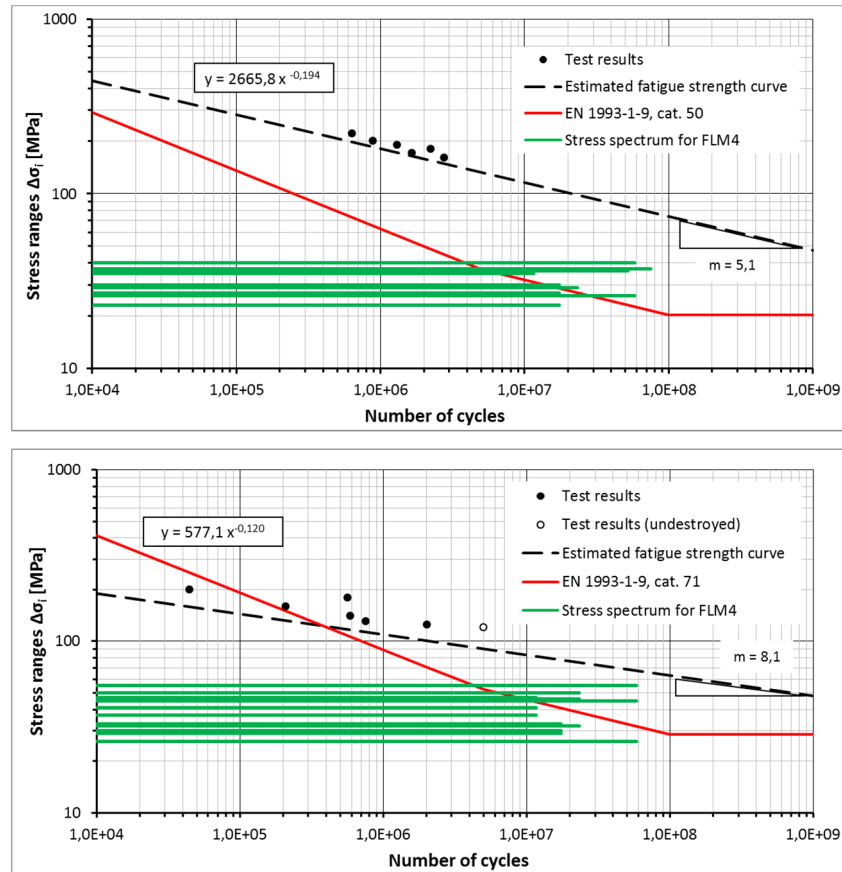
Fig. 6. S-N diagram for the detail no. 1 (top) and no. 4 (bottom) against the relevant curves [7]

The fatigue results are presented in S-N diagrams including the current relevant classification according to [7] (Fig. 6). Since the test data were used to determine the appropriate detail category for a particular construction detail, the value of the stress range $\Delta\sigma_C$ corresponding to the value of $N_C = 2$ million cycles was calculated for a 75% confidence level of 95% probability of survival for $\log N$. For details no. 1 and no. 4 the stress ranges were established experimentally as $\Delta\sigma_C = 158.8$ MPa and $\Delta\sigma_C = 101.0$ MPa, respectively.
