JOINT MOMENT-ROTATION CHARACTERISTIC IN LIGHT OF EXPERIMENTAL SIMULATIONS OF FRAME COLUMN LOSS

Aspects related to robustness of steel frameworks with semi-rigid steel and steel-concrete composite joints are dealt with. Experimental investigations were carried out for sub-frames fabricated in technical scale. Pushdown tests for steel sub-frames simulated the joint ability to transfer the bending moment and axial force under a column loss scenario. Tests on composite sub-frames were arranged in two stages. The first one was related to a service stage when the slab was under a gravity load and the column to be removed supported. The gravity load was sustained in the second stage when a column loss scenario was simulated. Experiments have shown that composite flush end-plate joints may not be robust enough since their low strength under sagging bending, despite of good ductility, does not allow for the redistribution of internal forces in order to achieve the equilibrium in the residual state after static column removal. Contrary, symmetrical steel and composite joints with extended end-plates on both sides of beam flanges seem to be more robust, despite of their lesser ductility. Rob

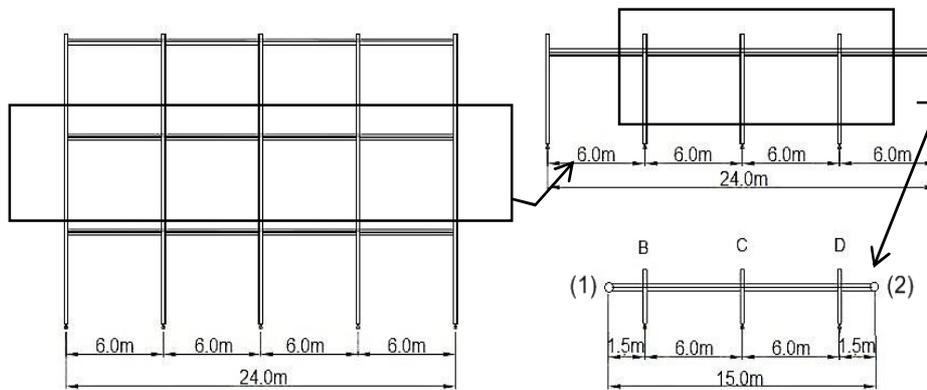
Fig. 1. Full scale sub-frame specimen cut off from a plane framework

had more internal space available for testing, full scale tests on a 3D multi-storey building framework were also not possible. It was then decided that tests would be carried out predominantly for the robustness assessment of local behaviour of joints in steel and steel-concrete composite frameworks. Tests were therefore performed on sub-frames of a plane multi-storey and multi-bay framework, consisting of three columns B, C and D, and two full length beams of two neighbouring bays B-C and C-D (see Fig. 1). In order to reproduce a real distribution of bending moments in beams under gravity load in a multi-bay structural frame, the sub-frame specimens were equipped with the short beams on both sides of each tested specimen, connected through pins (1) and (2) to the rigid side supports. Fig. 1 shows the way the tested specimens were cut off from a real framework.

In the external column joints (columns in the axes B and D, see Fig. 1), the situation was quite similar to that of the middle column (beam-to-column joints of both inner spans behave in a similar manner because of the structural symmetry). Rapid transition between the elastic behaviour and its inelastic behaviour due to bending and stiffness reduction related to an increase of membrane forces observed in the inner column joint was delayed and more gradual in case of outer column joints. The joint fracture occurring in the area near the top row of bolts (on the end-plate near upper flange) were smaller than that in the middle column joint under the same level of displacement increment.

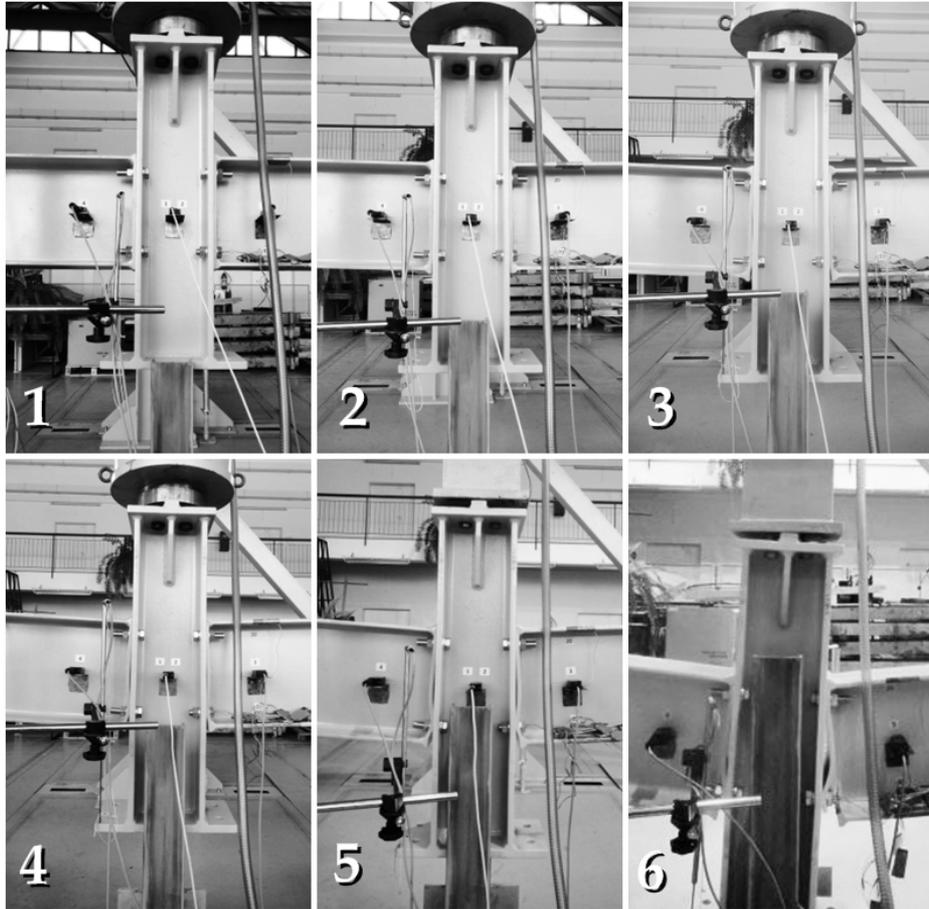
Fig. 2. Stages of progressive inner column joint deformations, from the initial configuration 1 to the final configuration at collapse 6

Joint deterioration signs were observed clearly at the thirty first displacement increment when the first signs of fracture were initiated at the lower flange level of the inner column end-plate joint subjected to bending and tension (column in the axis C, see Fig. 1). Since the end-plate started to fracture, the crack length was increasing along the lower flange to end-plate welds. Next, these cracks were further expanded and progressed beyond the beam flange to cover also the region along the beam web to end-plate welds in course of pushing the short column down by the hydraulic jack. Fig. 2 shows the deformation profile of the inner column and its joints starting from the initial configuration to the final configuration. One may note that despite of the geometry and loading symmetry of the specimen, the progressive deterioration of the specimen did not result in the simultaneous failure of two joints of the inner column. It is clear that the degradation of properties of one of the inner column joints started first (right side of short column in Fig. 2). As a result, the inner column started to rotate and the inner column left joint could not develop the same state of deformation at the final specimen configuration.

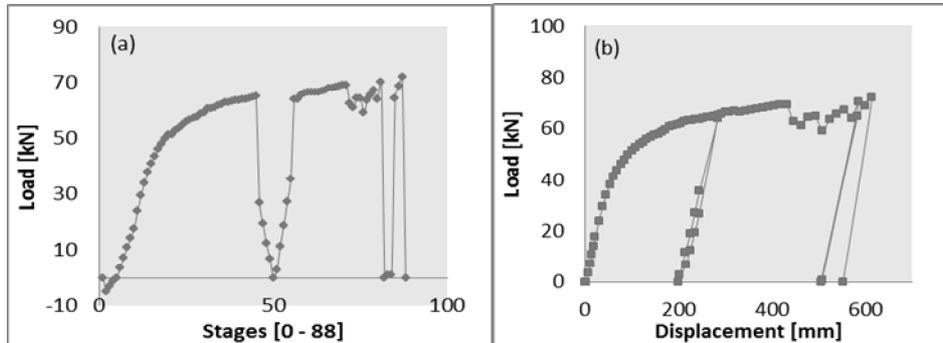
Fig. 3. Global characteristics of specimen 1: a) load - incremental step no., b) load - displacement
 Rys. 3. Globalna charakterystyka elementu 1: a) siła – numer przyrostu, b) siła - przemieszczenie

Fig. 3 shows the global behaviour of tested specimen 1 in terms of the load and increment steps, and the load and downward displacement characteristic.

The maximum value of applied load obtained in the test is equal to 69 kN and is associated with the short column displacement equal to about 430 mm in the displacement increment 71. The increments following that corresponding to the maximum applied load resulted in a progressive tearing of the fractured end-plate, extending along the tension beam flange and then progressing along the beam web towards the compression flange.

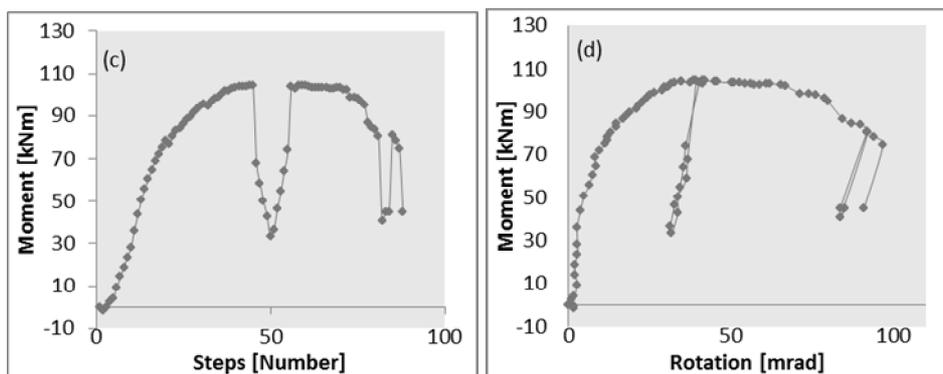
Fig. 4. Local characteristics of specimen 1 at inner column joint under sagging bending:
 c) moment - incremental step no., d) moment – rotation

Fig. 4 shows the local behaviour of tested specimen 1 in terms of the inner column joint sagging moment and incremental steps, and the inner column joint sagging moment and rotation characteristic.

Comparing the results presented in Fig. 4 and Fig. 5 one can conclude that the local responses of inner column joint under sagging bending and the outer column joint under hogging moment are similar in shape and the rotation magnitude at the ultimate moment. Only the ultimate moments are slightly different, namely 90 kNm vs 105 kNm.

Moment-rotation curves presented in Fig. 4d and 5f include implicitly the moments that are affected by the axial tensile forces generated in beams during the pushdown tests. It is important therefore to look at the membrane state developed in specimen beams pulled in pushdown tests and to evaluate the magnitude of beam tensile force in order to assess whether it affects the joint moment-rotation response obtained from experiments performed on isolated joints. Since tests on isolated joints being the same as used in sub-frame specimens considered herein were carried out under hogging bending by Barcewicz [10], there is a possibility for a direct comparison of joint properties.

Comparing the behaviour of flush end-plate and extended end-plate joints under sagging bending (Figs. 4 and 9) one can conclude that joints of extended end-plates exhibit a larger value of the initial stiffness and a higher value of the ultimate moment. The shape of the moment-rotation curve is however much different in both cases since the behaviour of extended end-plate joints is of a more brittle nature. The region of inelastic behaviour in case of latter joints is narrower and the attainment of their ultimate moment is followed by a rather steep descending branch of the moment-rotation characteristic. This is

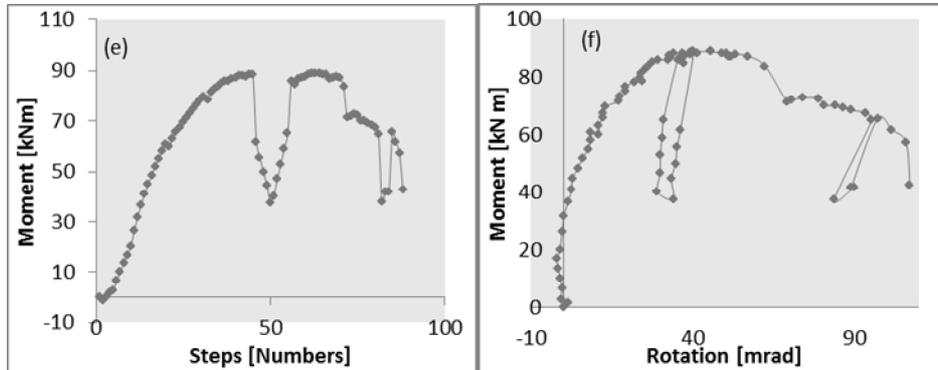
Fig. 5. Local characteristics of specimen 1 at outer column joint under hogging bending: e) moment - incremental step no., f) moment - rotation

Fig. 5 shows the local behaviour of tested specimen 1 in terms of the outer column joint hogging moment and incremental steps, and the outer column joint hogging moment and rotation characteristic.

an indication that extended end-plate joints may be more effective when used in frameworks where joints are purposefully made much stronger than members in order to ensure the inelastic redistribution of forces through the development of plastic hinges in beams. Contrarily, flush end-plate joints may be regarded more effective in frameworks where their robustness is ensured by ductility of joints. In this case, an optimal balance has to be sought of between the joint strength and ductility through choosing adequate constructional details (end-plate thickness, bolt spacing, weld type). The similar conclusion may be drawn when joints under hogging bending are considered (see Figs. 5 and 10).

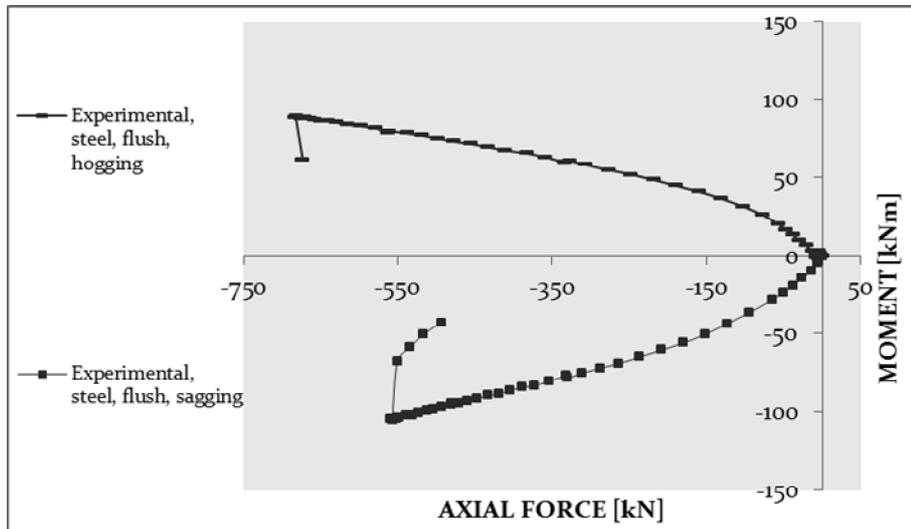
Fig. 6. Moment - force relationship of the flexural-membrane state at the inner and outer flush end-plate joints of steel specimen 1 (sign minus of the axial force refers to tension)

Fig. 6 shows the axial force at the inner joint subjected to sagging bending and at the outer joint subjected to hogging bending. It is observed that up to the point of attainment of the ultimate moment on the moment-rotation curve, the moment was being increasing when the axial force was increased. In the stage of joints collapse, referred to descending parts of the joint moment-rotation characteristic, the growing rupture of end-plates was associated with the decrease in both the bending moment and the axial force in considered joints.

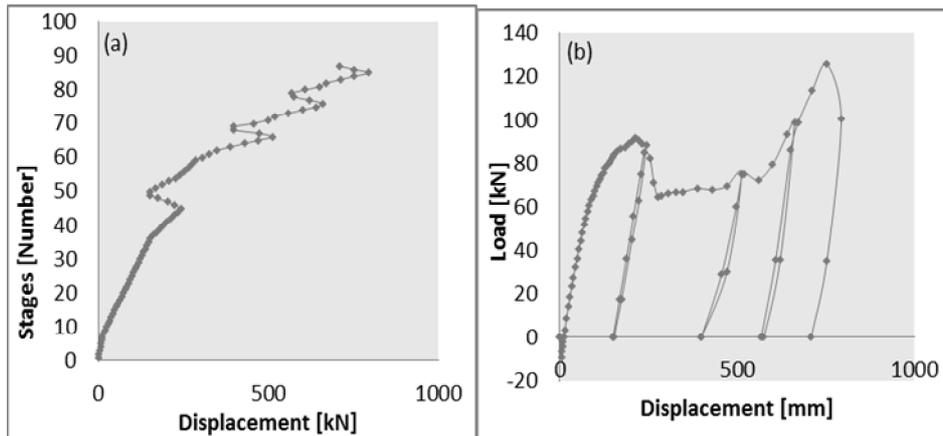
Fig. 7. Global characteristics of specimen 3: a) displacement - incremental step no., b) load - displacement

Fig. 7 represents the global behaviour of specimen 3. The jack arm was extended three times in contrast to the test 1 where the arm was extended only two times. Yielding of the extended end-plate was observed, and the first signs of end-plate fracture were observed in the inner joint of short column subjected to the application of downward vertical displacement. Cracks started at the end-plate cantilever part, outside of the lower beam flange when the vertical displacement of 98 mm was reached at stage 24. Extended end-plate and the column flange began to bend and the column web was subjected to transverse compression and tension. The beginning of the first fracture was at the lowest level of the beam flange to end-plate weld connection and extended along the weld connecting the end-plate and the beam section lower flange, increasing with the increase of the inner column displacement. The next fracture appeared inside of the beam flange to end-plate weld connection and increased with the increase of vertical displacement. The joint failure mechanism was associated with the fracture line extending also to the top flange along the beam

web to end-plate connection. The end-plate consequently split away from the welded area of the beam bottom flange. In the external column joints the situation was quite similar to that in the middle column but in a reverse way. The crack length in the area near the top row of bolts being in tension was however slightly smaller than in the distorted joint of the middle short column.

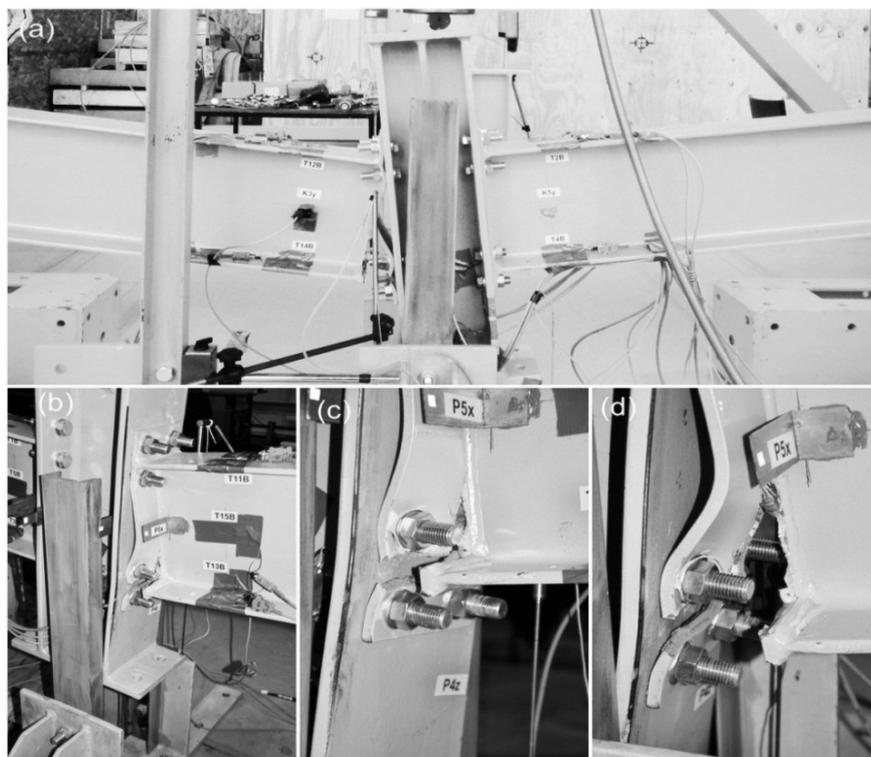
Fig. 8. Extended end-plate deformations; a) general view of the short column displaced configuration, b) detail of failed left joint, c) pulling out of the bottom flange, d) final stage

Deformations observed in the internal joint components and associated with end-plate tearing along the weld lines are presented in Fig. 8.

The maximum value of vertical load obtained for the original arm length of hydraulic jack was equal to 88 kN and it was associated with the displacement of short column equal to 243 mm. The increase of displacement was then associated with a descending branch of the specimen load-displacement characteristic and then the stage was reached in which the jack arm was too short to continue the tests. After the extension of jack arm, there was a further load drop to the level of 65 kN. This load remained almost at the same level until the displacement of 500 mm was reached. After that there was a progressive increase in load to 126 kN when the displacement reached 752 mm. This was at the point of specimen collapse.

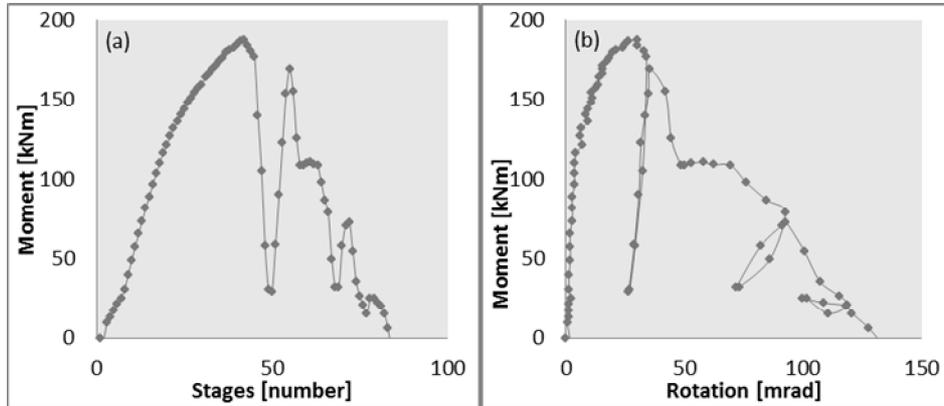
Fig. 9. Local characteristics of specimen 3 at the inner joint being under sagging bending; a) moment - incremental step no., b) moment - rotation

Fig. 9 presents the moment-rotation characteristic of the inner joint (sagging bending) and Fig. 10 shows the similar characteristic but for the outer joint (hogging bending) of the beam and short column deforming in the pushdown test.

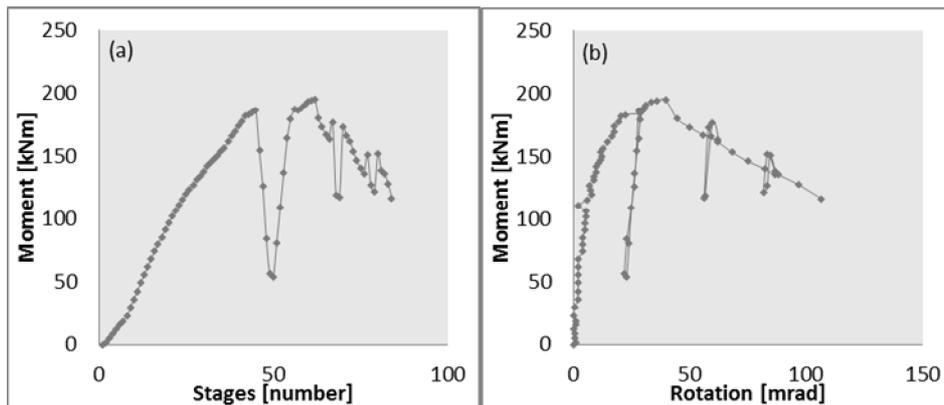
Fig. 10. Local characteristics of specimen 3 at the outer joint being under hogging bending; a) moment - incremental step no., b) moment - rotation

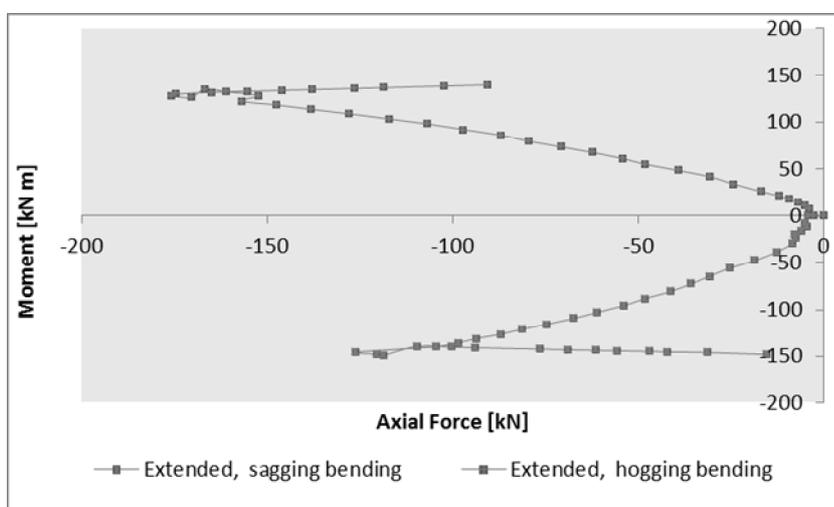
Fig.11. Moment - force relationship of the flexural-membrane state at the inner and outer extended end-plate joints of steel specimen 3 (sign minus of the axial force refers to tension)

Fig. 11 shows the axial force at the inner joint subjected to sagging bending and at the outer joint subjected to hogging bending. The smaller magnitude of the axial force in case of the specimen with extended end-plates in comparison to that of flush end-plates (see Fig. 6) is mostly related to the fact that there is a large region of the extended end-plate specimen behaviour in which the vertical load is being transferred by means of bending of stiffer and stronger framework joints. It is observed that the force reversal takes place at the point of joint behaviour when the moment is less than that of its maximum value. This was corresponding to the point of fully cracked joints on the outside of the tension flange. The similarity might be noted for the moment-force diagram extent for the any end-plate joint being under sagging and hogging bending.

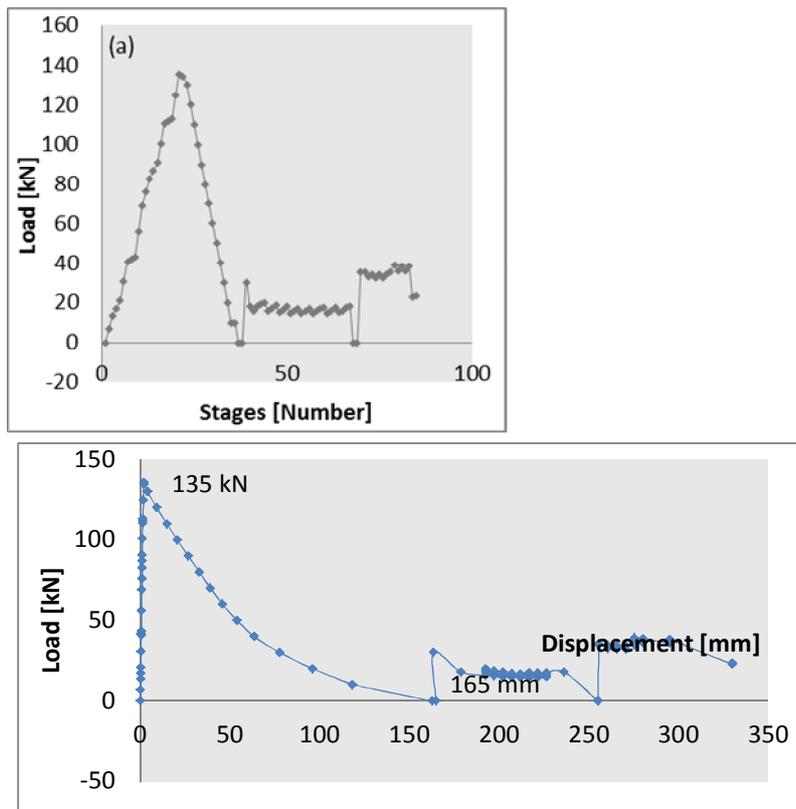
Fig. 12. Global characteristics of specimen 2: a) load - incremental step no., b) load - displacement

Fig. 12 illustrates the behaviour of specimen 2 with composite flush end-plate joints. The first stage indicated by the vertical line in Fig. 12b shows the stage of the service load when the internal column is supported and hanged by the jack arm. The successive loading of the specimen by concrete blocks is represented in Fig. 12a by an inclined curve consisting of a zigzag line the pieces of which represent two successive steps of laying down stages of concrete blocks. First was done in one span leading to an asymmetric loading

pattern and the next one - in the other span, leading to restoring the symmetrical loading pattern. The first stage of loading caused a vertical reaction in the internal column equal to 135.6 kN. At this stage, first signs of cracking in the concrete slab were observed in the vicinity of the outer column. The second stage of successive application of displacement increments was related to a simulation of the static column removal process. It resulted in a slow reduction in the magnitude of vertical reaction, with a continuous loss of the specimen stiffness. The joints yielded progressively, mainly by the increased plastic deformations of the steel components of inner composite joint, namely yielding of the column web, end-plates and column flange being in bending, beam flange and web in tension, and for the external composite joints - by yielding of the column web in compression and yielding of slab reinforcing bars being in tension. During this stage, the cracks in the vicinity of the external composite joints were more pronounced and yielding of some steel joint components was observed. For the internal composite joint, a separation of the end-plate was seen under sagging moment and the fracture was observed more clearly around the bottom bolts row. The concrete cracks in the vicinity of external composite joints continued to enlarge and yielding appeared in rebars followed by yielding of steel components in the compression zone. The most important phenomenon to be mentioned is the crushing of the concrete in the inner composite joint (axis C in Fig. 1). The maximum vertical force recorded in the hydraulic jack was reached at an instantaneous static equilibrium that was in response to the vertical displacement of 165 mm. This state was however associated with the rapid progression of end-plate fracture tearing and concrete crushing close to the internal column, and with the drop in the magnitude of reactive force. As a result, the permanent static equilibrium could not be reached in the stress redistribution process. Failure of the frame was caused by progressive cracking in the joint end-plates near welds connecting them to the beam bottom flange, and also by yielding of reinforcing steel bars in the external joints. The longitudinal rebars in the external composite joints were progressively more stressed, the concrete there more cracked under tension and concrete at the internal joint was progressively crushed. At the latter point, further yielding was developed in the different components of composite joints. Illustration of successive states of internal joint deformations is presented in Fig. 13. The state 1 corresponds to the initial configuration, state 2 to the final state of the 1st stage of loading, and the following states are referred to the 2nd stage of loading program.

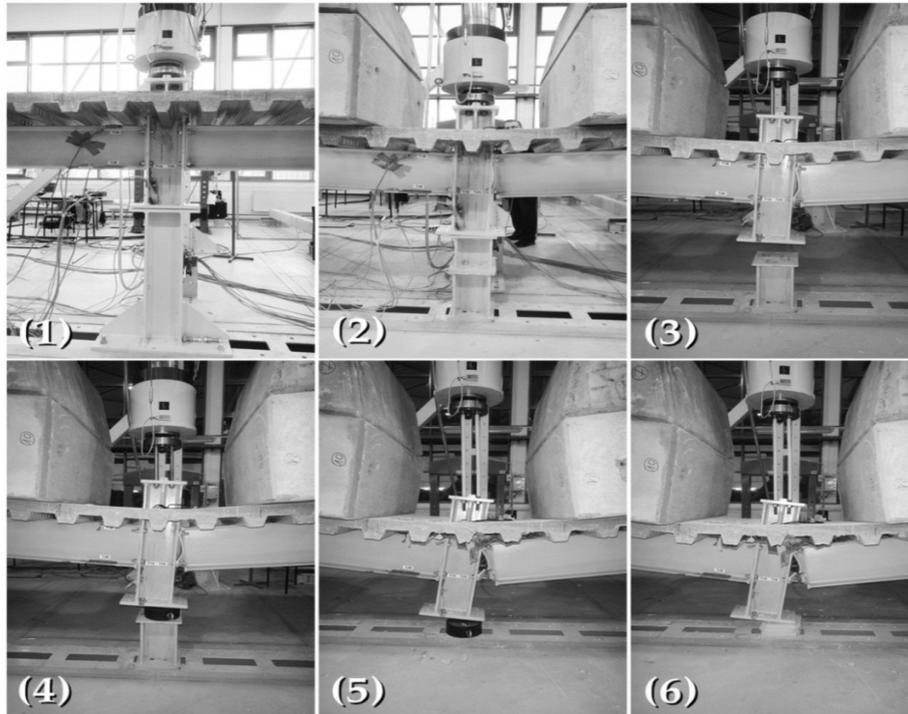
Fig. 13. Illustration of successive deformation states of internal column joint

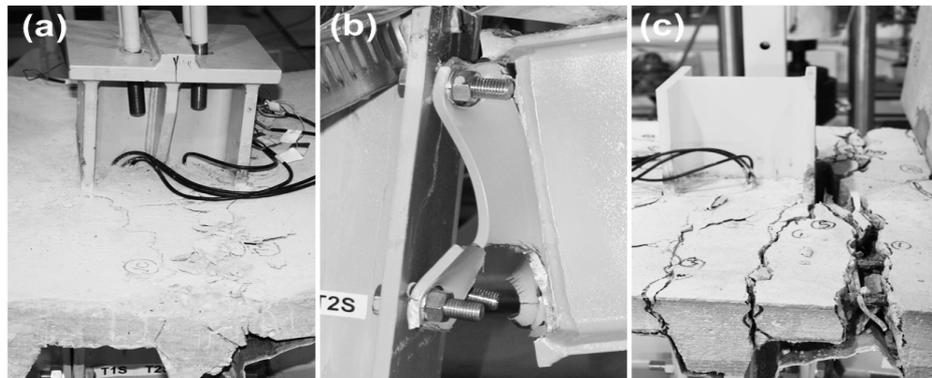
Fig.14. Details of joint components deformation; a) crushing of concrete slab of inner joint, b) fracture of end-plate of inner joint, c) cracking of concrete slab of outer joint

The final stage is referred to the specimen collapse indicated by large deformations of an extensively cracked end-plate of the inner composite joint and a substantial crushing of the reinforced concrete slab. The outer joint is at a different state and the specimen failure results in this joint in yielding of rebars and large cracking of concrete. The details are shown in Fig. 14.

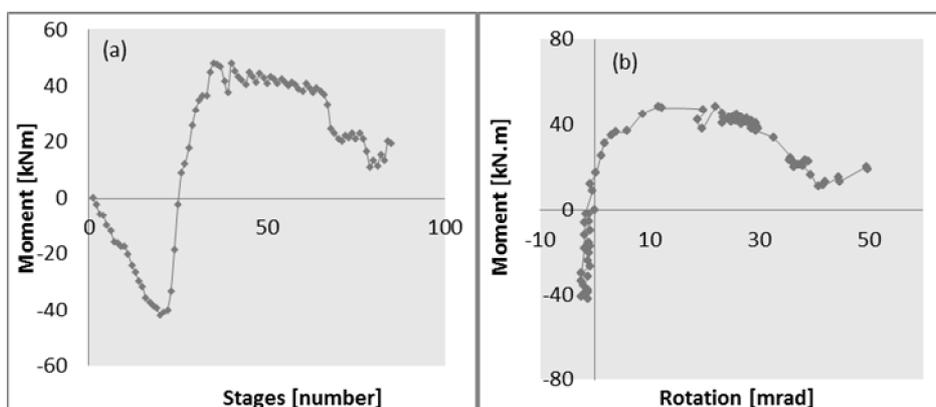
Fig. 15. Local characteristics of specimen 2 at the inner joint being under hogging bending in the first stage of loading by concrete blocks, and then reversing to sagging bending in the second stage of static column loss simulation; a) moment - incremental step no., b) moment - rotation

Fig. 15 shows the moment-rotation characteristic of the composite inner joint subjected to two stages loading program. Since the inner column was in the first loading stage hanged, the support exerted the reactive force. The joint reached the hogging moment of approximately 40 kNm at the end of the first stage of loading program. During the simulation of the static column loss scenario, the joint was subjected to reversed rotation since the incremental settlement of inner column support reduced progressively the reactive force causing the moment to change the sign from hogging to sagging bending.

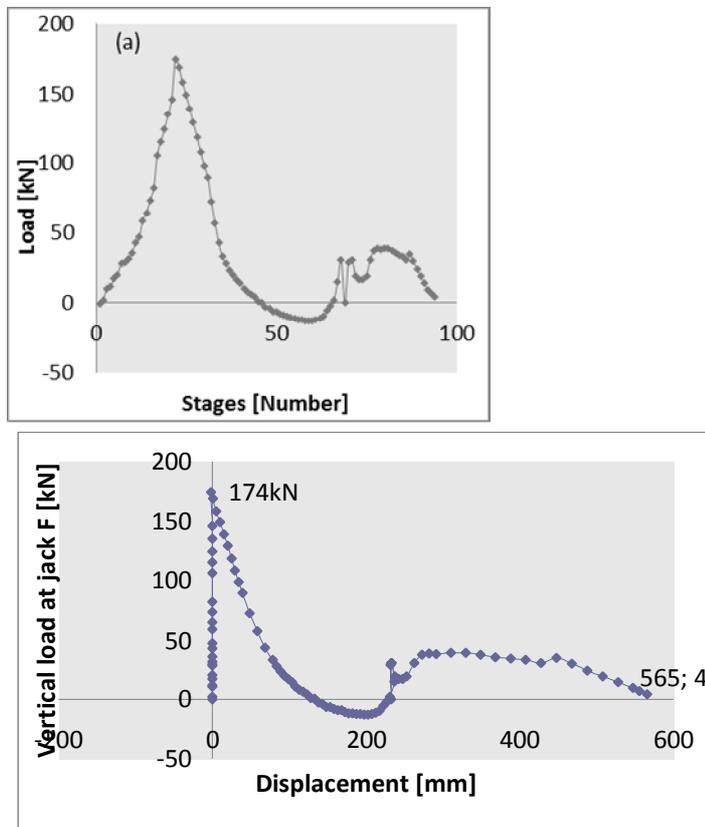
Fig. 16. Global characteristics of specimen 4: a) load - incremental step no.,
b) load – displacement

Fig. 16 shows the global behaviour of composite specimens 4. In the first stage of the loading program, referred to the vertical line, an increase in the vertical reactive force at the middle column is observed which was associated with a progressively increased uniformly distributed load.

The maximum value was equal to 174 kN. The specimen was still in the quasi-elastic region when the maximum reaction was reached. Then, as previously mentioned, a vertical displacement was progressively imposed until the collapse of the tested specimen. At the second stage of column loss simulation scenario, the sub-frame entered into yielding and catenary action states, with the force finally reaching the maximum absolute value on the opposite side to that for the first stage of loading. During this stage, the cracks at the outer composite joints were clearly visible with yielding and rupture of steel components of the joints observed. Fig. 17 shows the total collapse of the inner joint after the complete crushing of concrete and end-plate fracture resulting in pulling out of the beam tension flange followed by the detachment of end-plate.

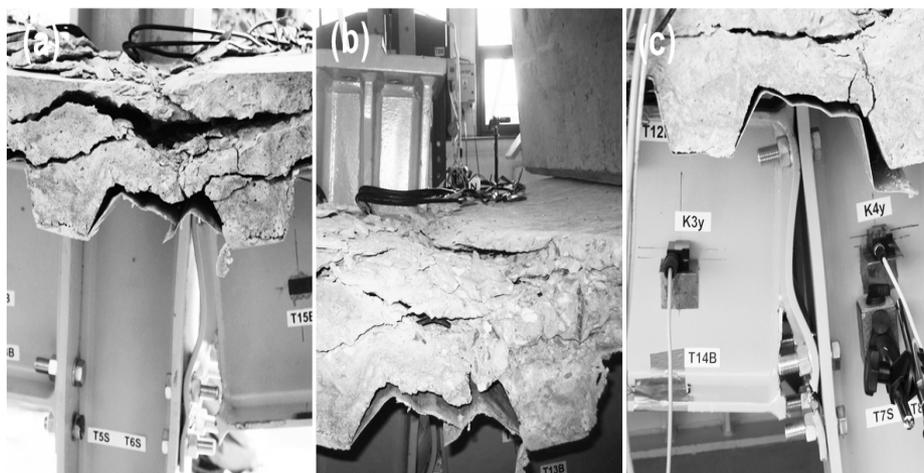
Fig. 17. Details of the inner joint deformation at collapse, a) general view, b) concrete crushing, c) end-plate fracture

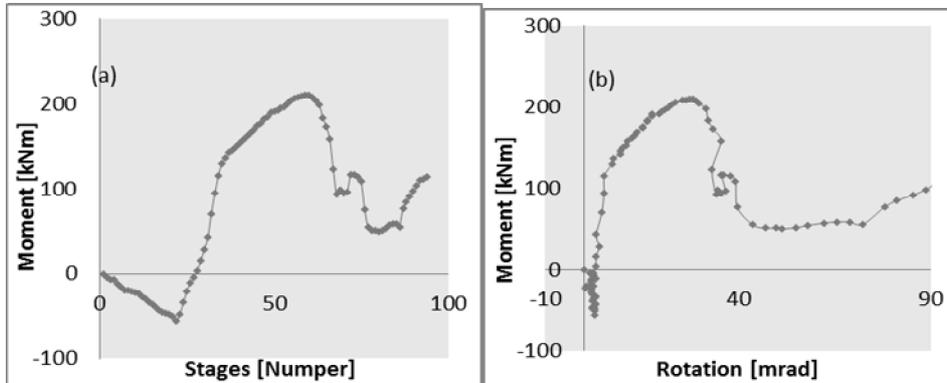
Fig. 18. Local characteristics of specimen 4 at the inner joint being under hogging bending in the first stage of loading by concrete blocks, and then reversing to sagging bending in the second stage of static column loss simulation; a) moment - incremental step no., b) moment - rotation

Referring to study presented by Barcewicz [10], it had been expected that composite flush end-plate joints would be more flexible in the first stage of loading program, i.e. under hogging bending, than those of extended end-plates. This would in turn result in a different local behaviour of inner column extended end-plate joint subjected to two stages loading program. The local behaviour of inner column composite extended end-plate joint is presented in Fig. 18. Comparing the local behaviour of flush end-plate and extended end-plate joints in the first stage of loading one can conclude that the latter one reached a lesser hogging moment at the end of first loading stage, and then a higher sagging moment at the end of the second stage of loading program.

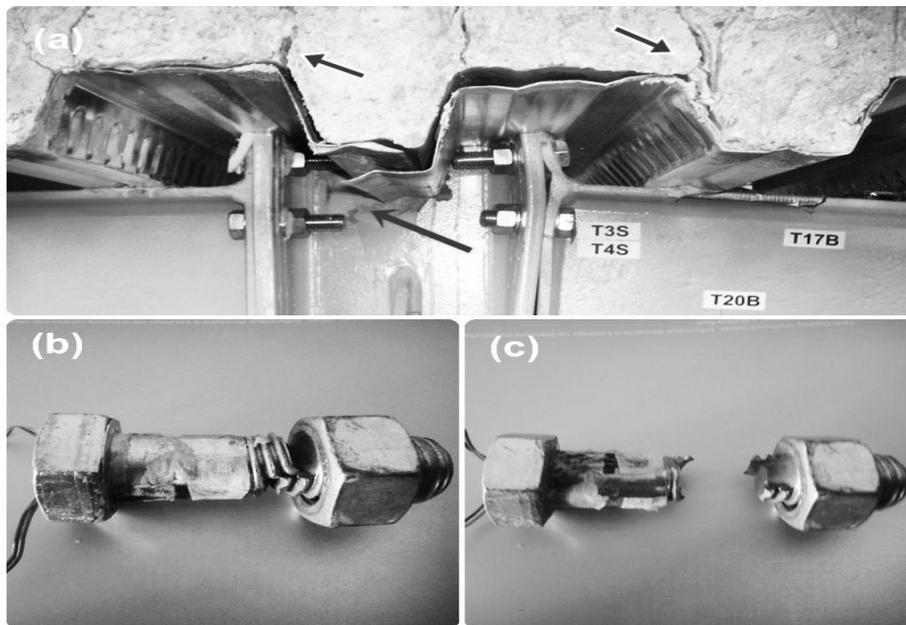
Fig. 19. Details of the outer joint; a) concrete cracking and separation of profiled sheeting, b) damaged bolt, c) fractured bolt

External column joints are subjected to hogging bending in both stages of loading program. Tension of external composite joints continued causing yielding of steel components and cracking of concrete (see Fig. 19). The longitudinal reinforcing bars at the external composite joints partially failed. The reduction of joint stiffness is observed and it is linked to the loss of longitudinal reinforcing bars in the vicinity of the external joints. The stiffness of the outer joint is decreased also due to the fracture of one of the most stressed bolts as a result of bolt tension and bending.

The examination of the most stressed bolts after the test showed that the broken bolt had the fracture at the threaded length while the other bolt was almost fractured. Details are given in Fig. 19b,c. The test ended with only 7 bolts instead of 8 and with one of the most stressed bolt row being heavily damaged. As it was discovered later on, after the test, the nuts of failed bolts were by mistake of the lower class than required for the bolted connectors used in the joint.

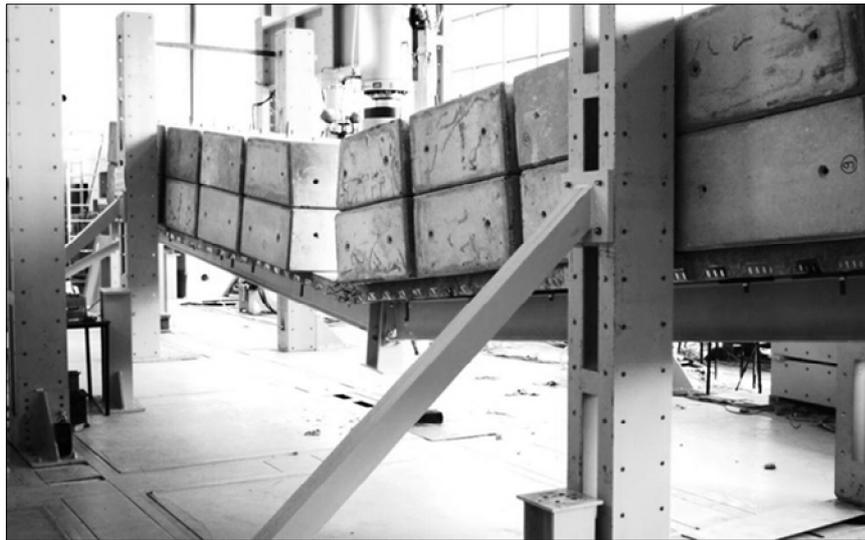
Fig. 20. Final deflected configuration of specimen 4 with the composite joints

The final deformation profile of composite extended end-plate specimen configuration is shown in Fig. 20. It can be seen that this configuration was associated with large displacements. Concrete blocks at this state were stably positioned along the beams of tested specimen.
