Grzegorz GREMZA¹
Jan ZAMOROWSKI²

DAMAGE ANALYSIS OF THE BLADE TO THE ROTOR HUB CONNECTION IN THE WIND TURBINE

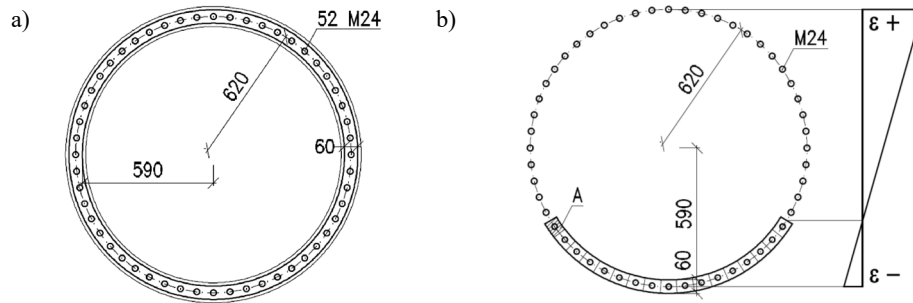
In the connection of the blade with the hub (Fig. 8a), a linear distribution of deformations was assumed, as in the structural members subjected to alternate actions [3]. It was assumed that the load in the compression zone is transferred by a pressure of a ring of bearing on the hub, and in the tension zone – by the bolts tension. In this model, a pressure of the ring on the hub caused by preloaded bolts is not taken into account. The effective section was determined, in which the bolts transmit tension and the flange transfers pressure (Fig. 8b). In the calculation of the connection characteristics, the nominal cross-section of the bolt has been adopted.

Fig. 8. Connection: a) view, b) scheme of calculation (effective cross-section)

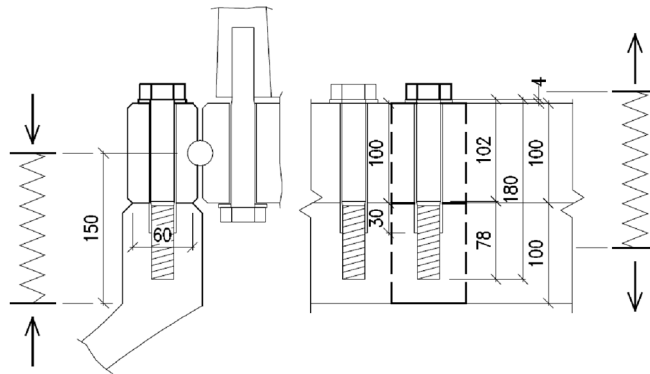
The connection of the rotors' blade to the hub was calculated using a mechanical model consisted of 52 basic components of the joint. The number of these components corresponds to the number of bolts. Each component was modelled as a spring (Fig. 9), whose axis coincided with the bolt axis, both in tension and compression zone. The stiffness of the spring in the compression zone was estimated based on the elastic shortening of the pre-compressed part of the ring (bearing race) and the hub with a length corresponding to 1/52 of the connection perimeter and a thickness of 15 cm – see Fig. 9. In the calculations, Young's modulus $E = 210$ GPa and the pressure area of the ring for the hub $A = 39.5$ cm² (see fig. 8b) were adopted. The stiffness of the spring $k_c = EA/l = 5\,530$ kN/mm was obtained, where $l = 150$ mm is an effective length of the spring – see fig. 9.

Fig. 9. Fragment of the joint and its modeling as springs in compression and tension zones

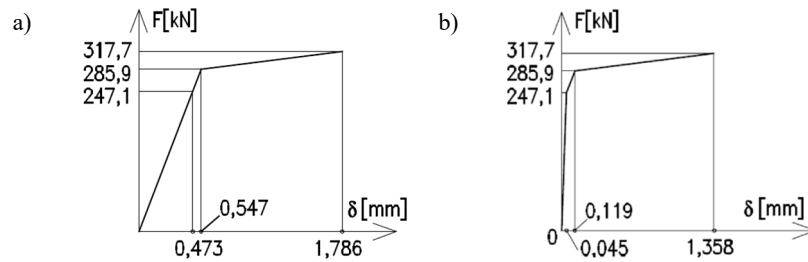
The obtained characteristic of the basic part of the joint in the tension zone is shown in Figure 10b.

Fig. 10. Force – displacement characteristics: a) for bolt M24 class 10.9, with the actual length of its shaft and its threaded part b) for the basic component in tension in the pre-stressed connection

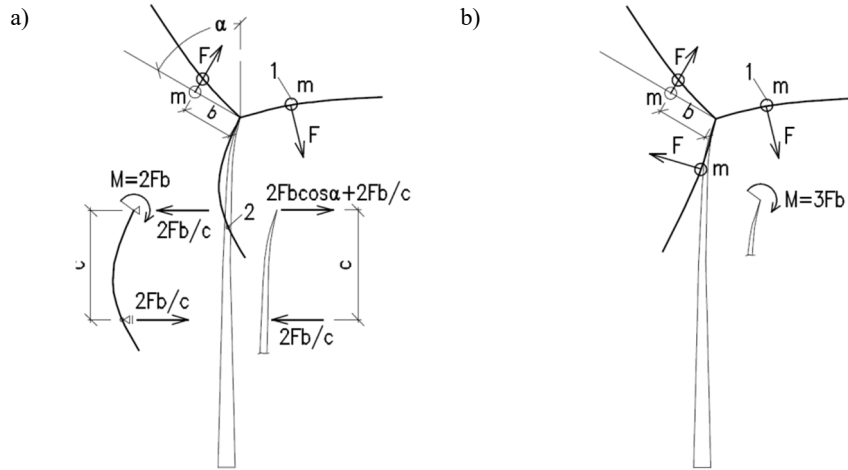
Adopting the highest operational rotational speed of the rotor $\Omega = 30.8$ rpm, the velocity at the point of the centre of gravity of the blade $V = 25.65$ m/s has been obtained. It was assumed that the two upper blades stop as a result of blocking the movement by the third lower one, which acts as a brake together with the tower (similarly to a bump post e.g. in crane girders). The upper two blades (Fig. 11a) act on the axis of the system with the horizontal force F_{hub} and the moment M_{hub} :

Adopting the above assumptions and calculating necessary stiffness coefficients, the bending moment in the connection of the lower (blocked) blade to the hub equal to 5 949 kNm was obtained. (Detailed formulas allowing the calculation of the bending moment in the connection together with their derivation will be presented in a separate publication.)

Fig. 11. Schemes of a structure work: a) blade collision with the tower, b) sudden shaft locking

Similarly to the point 7.3. the greatest operational rotational speed of the rotor 30.8 rpm was adopted. It was assumed that the rotor at the moment of its sudden blockage acts on the tower with a moment (Fig. 11b):

In the case of the load resulting from the blockage of the movement of the blades, bolts fracture would be potentially possible, because the forces acting on them would be slightly larger than their design resistances calculated in accordance with the standards.
